A Rapid Trash Assessment Method Applied to Waters of the San Francisco Bay Region: Trash Measurement in Streams

California Regional Water Quality Control Board
San Francisco Bay Region
August 23, 2005

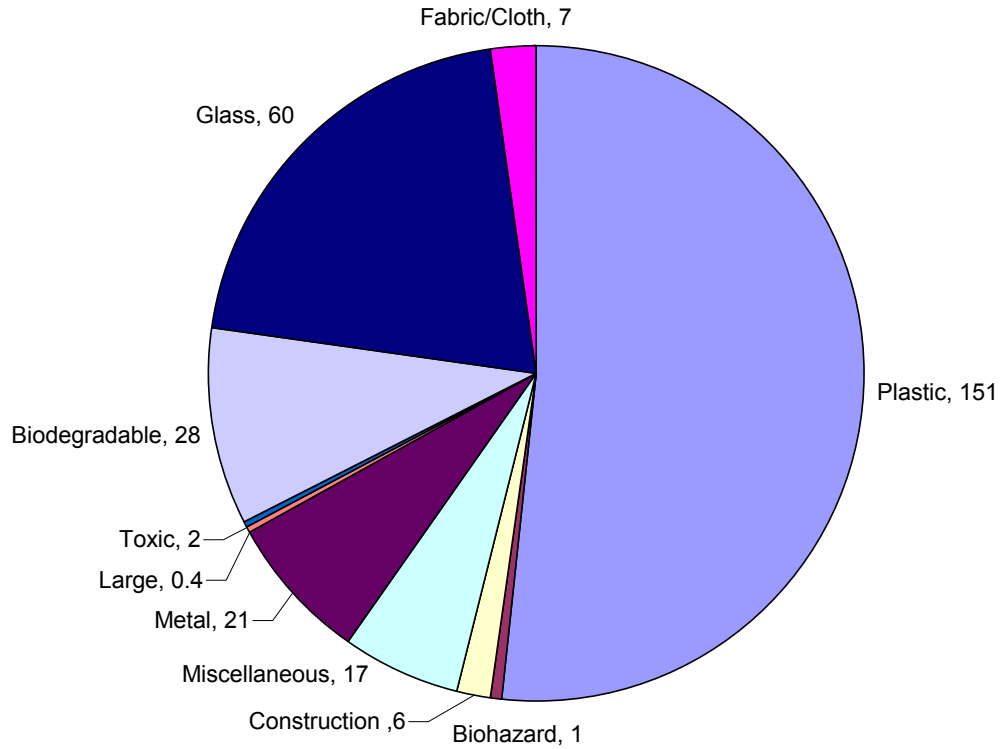
Figure 2: Average number of pieces of trash, by category, per 100 foot reach for all sites and all seasons.

The 85 site visits conducted by Water Board staff and students over three years and multiple seasons confirmed that high levels of trash are present throughout urban streams in the San Francisco Bay Region. On average, across all sites and seasons, 293 pieces of trash were collected per 100 foot reach of stream, equaling 2.93 pieces per linear foot of stream (Figure 2). Over 50% of this total, or 1.51 pieces per linear foot of stream, was composed of plastic items. Glass (21%) and biodegradable items (10%) were also commonly found. Most sites contained less than 500 pieces of trash, while several sites contained many more pieces, up to a maximum of 1133 pieces, or 11.33 pieces per linear foot of stream (Figure 3). Overall, 72% of all trash items were found below the high-water line, while 28% of items were found above the high-water line. Certain types of items were found almost exclusively below the high-water line, including toxic items (88%), construction debris (87%), and glass (82%). Forty-one percent of biodegradable items were found above the high water line, indicative of the frequency with which paper is transported by wind into stream channels. The average total Rapid Trash Assessment (RTA) score was 47, with a range from 8 to 112 (out of a possible 120) (Figure 4). Lower RTA scores reflect higher levels of trash. A high RTA score, overall or in a specific category, represents more desirable, less trashed conditions. Total RTA scores were strongly related to the number of plastic pieces found at sites (Figure 5).

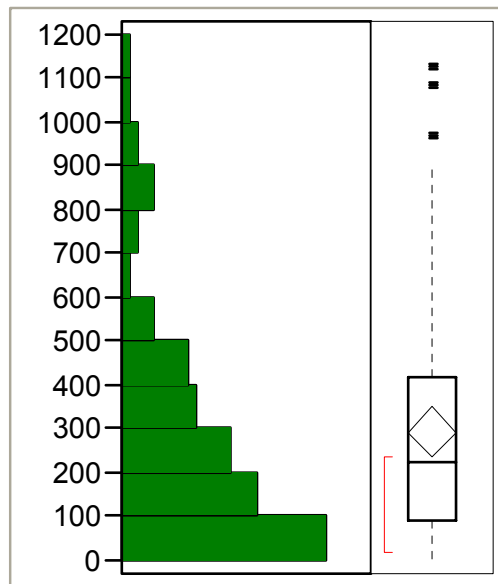
Figure 3: Frequency histogram of the number of pieces of trash found per 100 foot reach (site). The diamond indicates the mean and the standard error about the mean. The box indicates the median and the 25th and 75th percentiles, while the whiskers indicate the 5th and 95th percentiles.

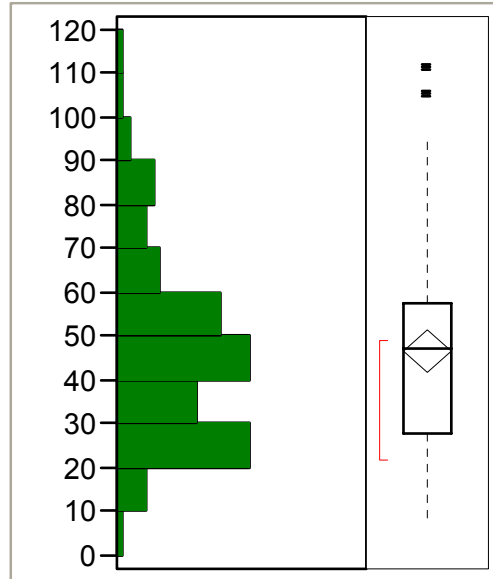
Figure 4: Frequency histogram of total RTA trash scores for each site visit. Symbols are the same as in Figure 3.

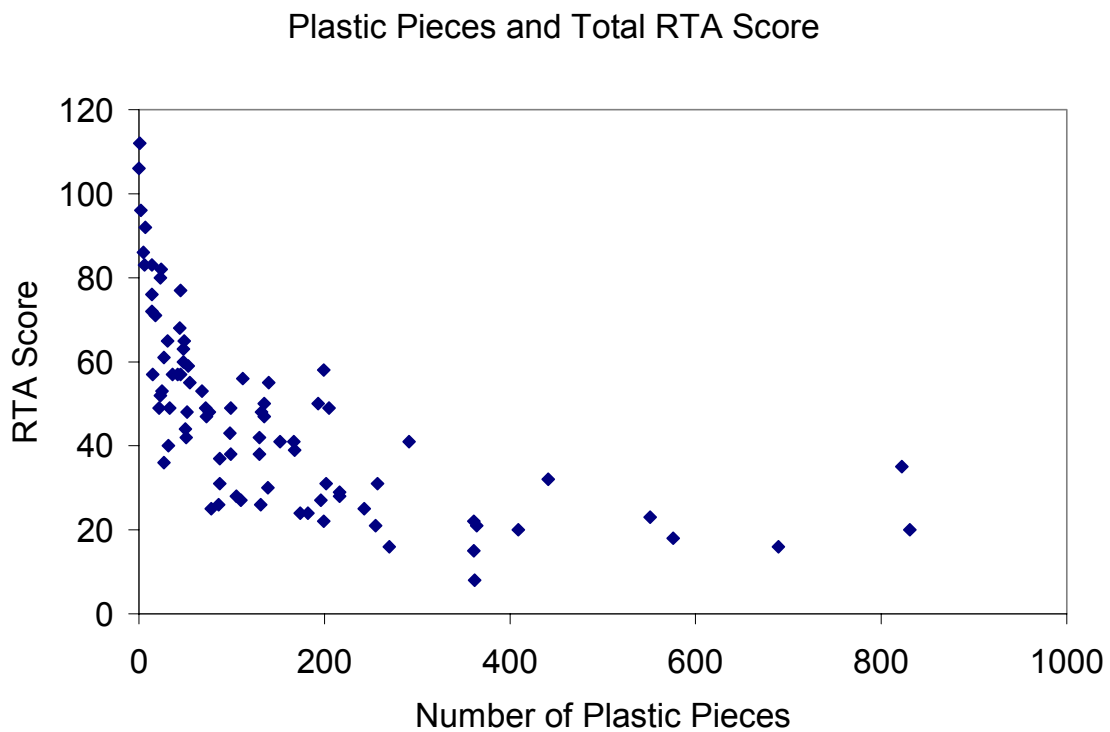
Figure 5: Total RTA score relative to the total number of plastic pieces found at sites.

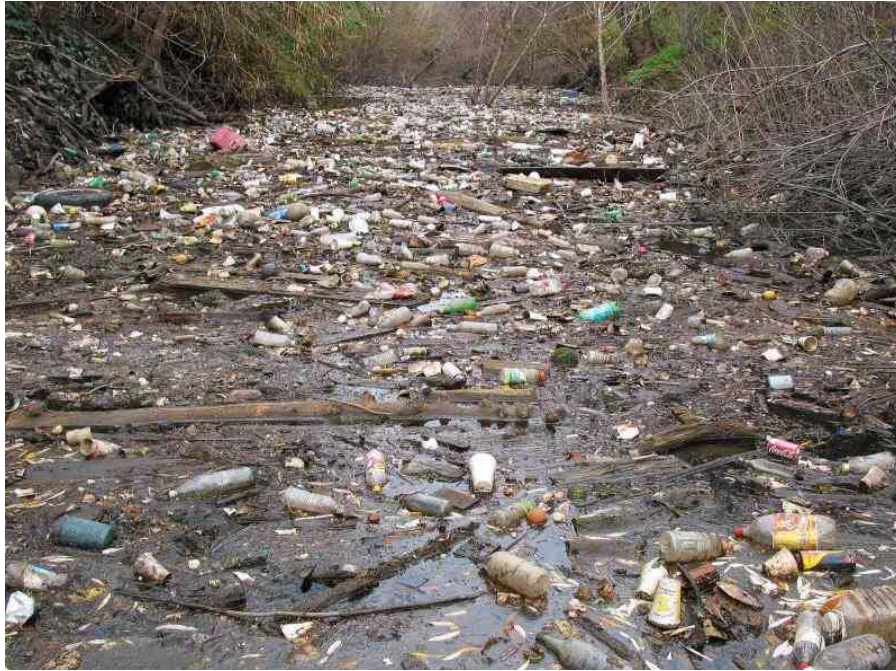
Figure 6: Photo of the trash buildup behind a fallen tree immediately downstream of the Julian Street bridge, Coyote Creek, San Jose, CA, January 27, 2004. Photo by Friends of Coyote Creek.

The 26 sites surveyed did not include the worst-case conditions of trash in the region (Figure 6, below, for example), where obstructions can cause buildup of floating trash in

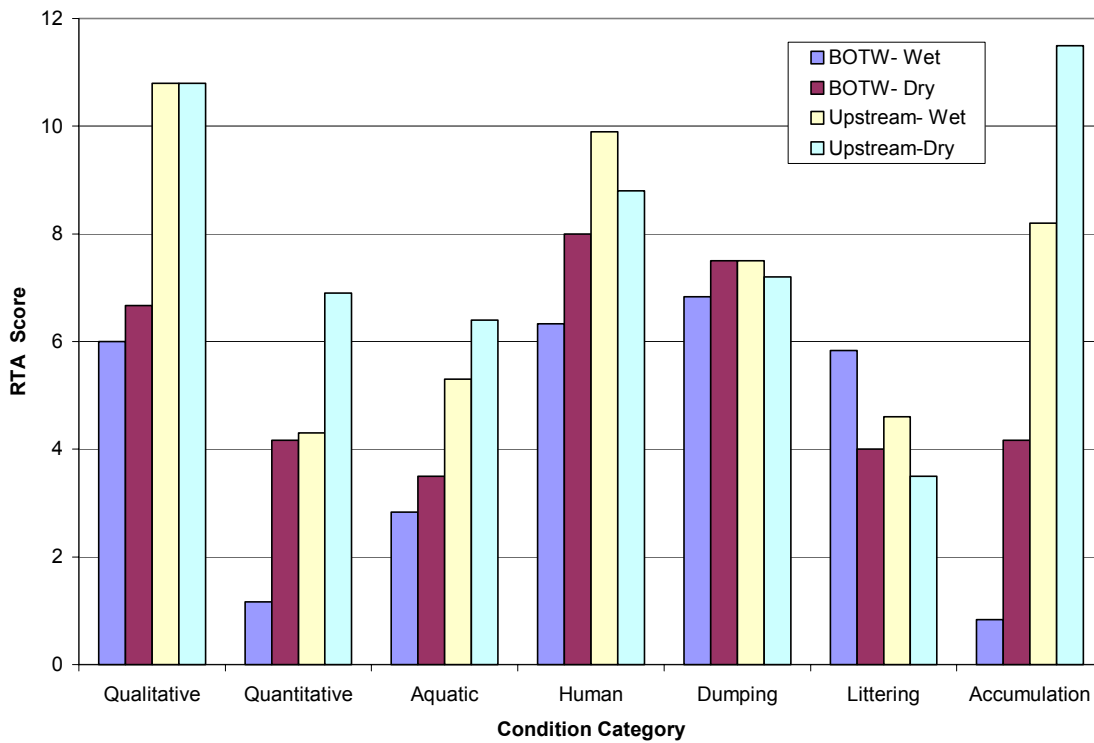
Figure 7: Average condition category scores from a subset of sites that were sampled during revisits that bracketed both wet and dry seasons. Data is presented for both wet and dry season surveys from 6 BOTW sites and 10 upstream sites. Maximum RTA scores for all condition categories is 20, except littering and dumping which is 10.

Condition category scores within the total RTA score reflected differences in trash deposition between both (1) wet and dry seasons and (2) BOTW and sites further upstream. Figure 7 presents a comparison of average RTA scores at a subset of sites where site revisits well-bracketed both the wet and dry seasons. Bottom of the watershed (BOTW) sites tended to score lower than sites further upstream in the watershed in nearly all trash condition category scores, with the exception of dumping and littering (Figure

7). Qualitative scores were much lower at BOTW sites than upstream sites, indicating the “first impression” of BOTW sites is consistently more negative with respect to trash.

Accumulation scores were also much lower at BOTW sites than upstream sites, but wet season scores are much lower for both site locations than dry season scores, reflecting the seasonality of trash accumulation. At BOTW sites, the dry season scores for accumulation were markedly lower than the wet season accumulation scores for upstream sites, shown at the far right of Figure 7. As noted above, at BOTW sites the trash is dominated by plastics. The graph at the far right of Figure 7 therefore shows that plastics continue to be delivered to the bottom of watersheds and into the San Francisco Bay during the dry season. Trash can be delivered to streams, the topographic low points in watersheds, by wind and dry season urban runoff (e.g., over-irrigation), and these data suggest it is a significant source. Trash control efforts in the Los Angeles region associated with TMDL implementation tend to focus on runoff events to capture the largest volume of trash, but the observations documented in this report show that dry season delivery of trash is likely significant.

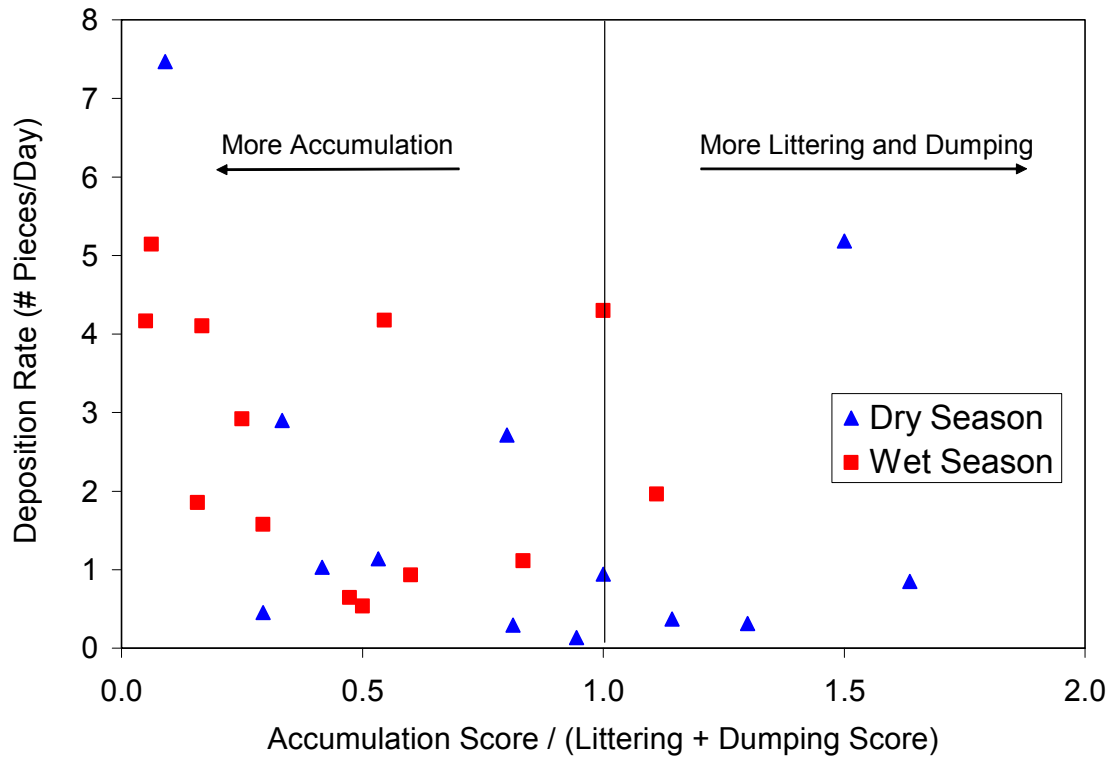
Figure 8: Deposition rates at sites versus the relative importance of accumulation from upstream and localized littering and dumping.

Deposition rates were much lower in the dry season than the wet season, generally below 1 piece of trash per day (Table 1, Figure 8). Several sites had high deposition rates during the dry season, associated with localized littering (Figure 9). Many of these high dry season deposition rates occur at public parks. Management priorities at these sites should focus on encouraging the proper disposal of trash in and around the stream.

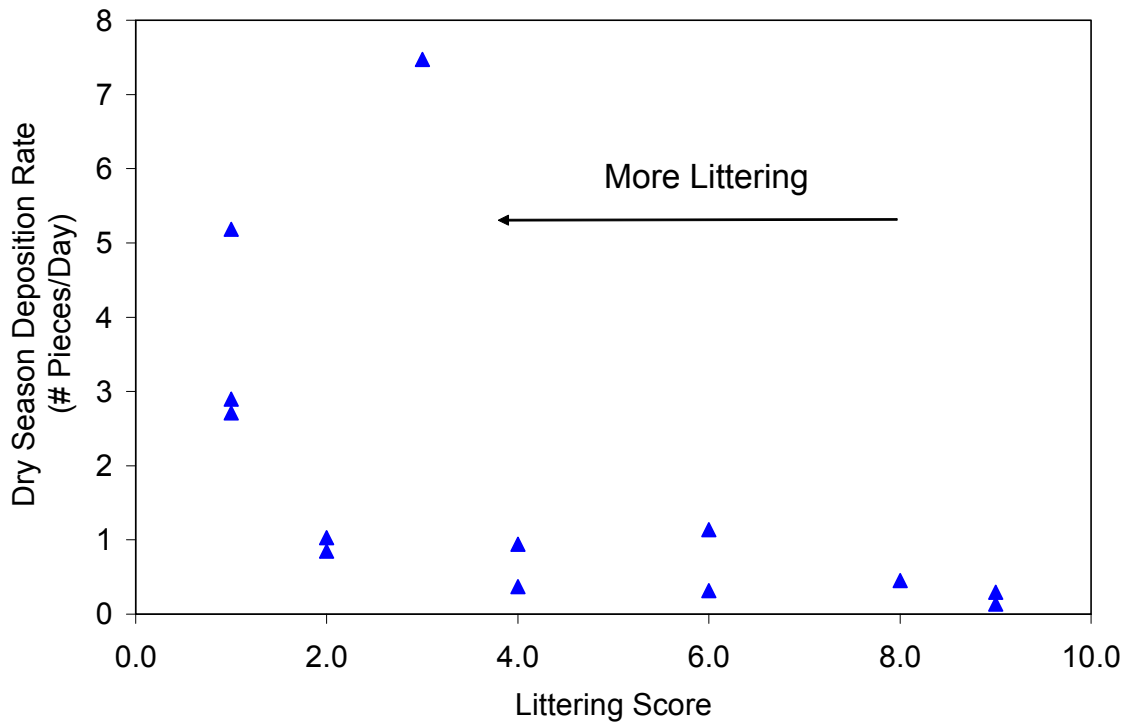
Figure 9: Dry season trash deposition rates relative to the RTA littering score.

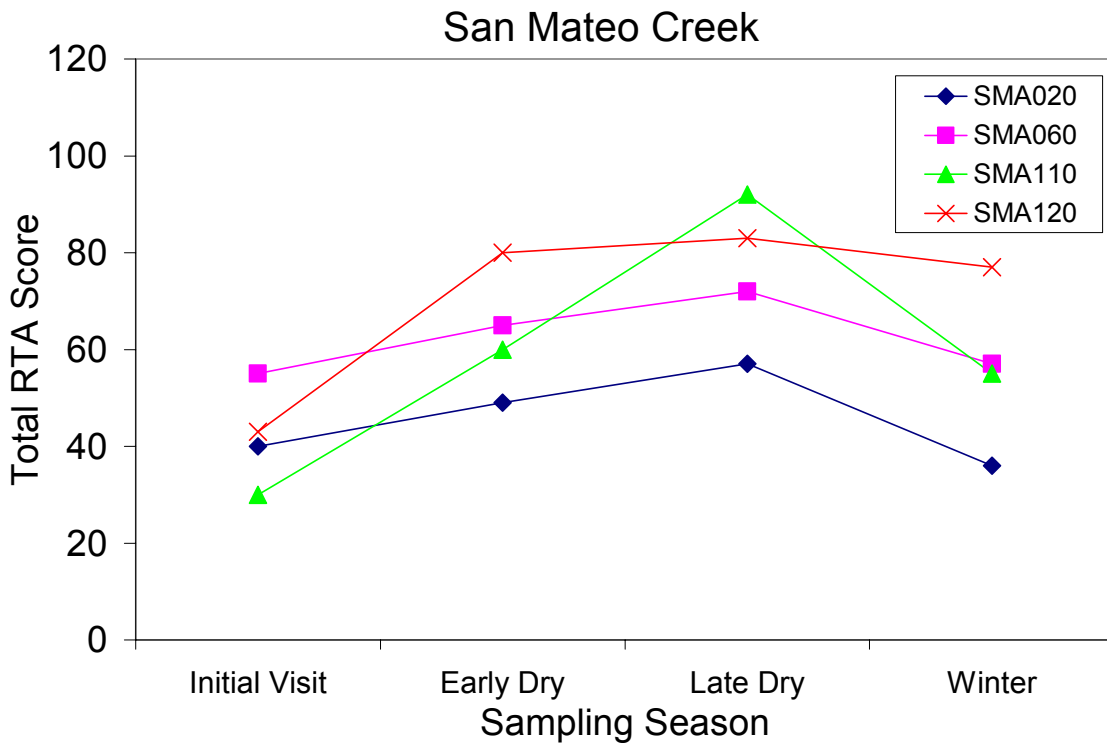
Figure 12: RTA Scores at four sampling sites in the San Mateo Creek watershed along a longitudinal gradient. SMA020 is the lowest site, and SMA110 and SMA120 are the highest sites, both upstream of a confluence of Polhemus and San Mateo creeks.

In Figure 12, the longitudinal trash characteristics of San Mateo Creek are apparent. The lower Gateway Park, though not initially having highest trash levels, had higher sustained trash levels and hence lower RTA scores. Arroyo Court Park, located 2 miles upstream but within urbanized portions of the city, tracked closely with Gateway Park, with higher scores in each season. Polhemus Creek, with the lowest initial score, had higher levels after trash was removed, but wet weather brought a significant return of trash from this residential area. The upper San Mateo creek site saw less return of trash with wet weather, due to less upstream urbanization. This site, known as SMA120 in Figure 12, exhibited the desirable pattern of higher initial levels and less return of trash after “management,” or cleanup associated with the RTA protocol, during both dry and wet seasons. Dry season RTA scores were lower at the Gateway and Arroyo Court Park sites, due to direct littering documented at these more publicly accessible sites.

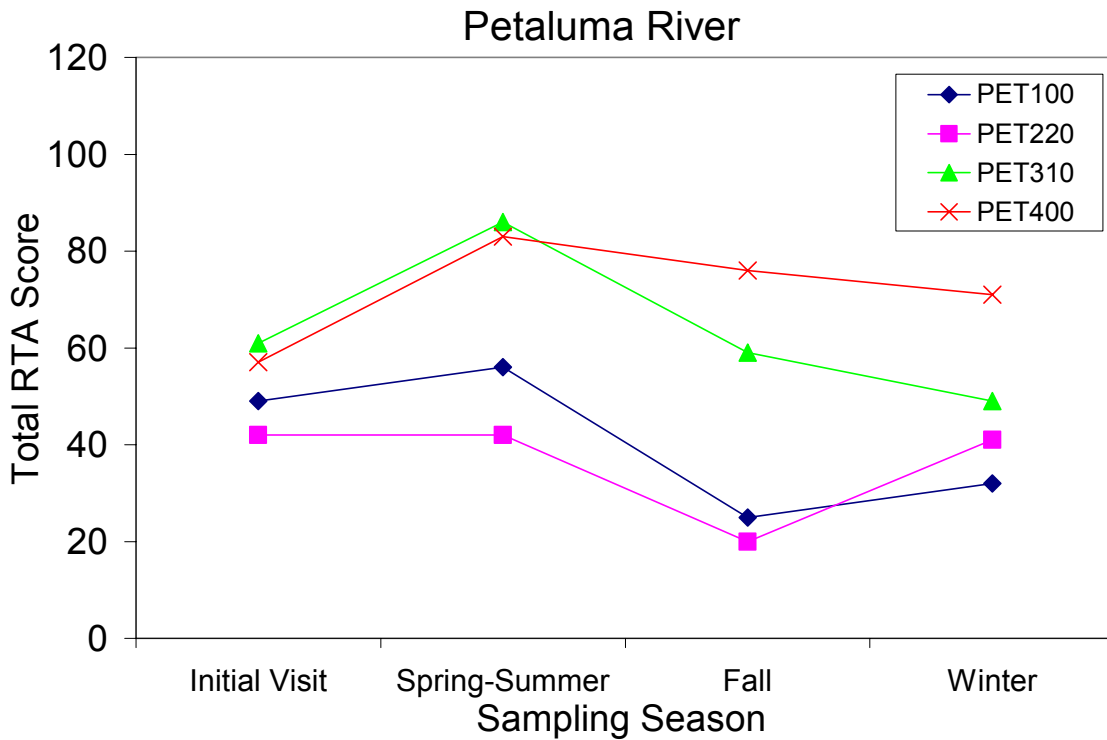
Figure 13: RTA Scores at four sampling sites in the Petaluma River watershed along a longitudinal gradient. PET100 is the lowest site, PET310 is upstream on the main branch, and PET220 and PET400 are the tributary sites. PET220 tributary (Washington Cr.) enters the main branch downstream of PET310. Except for PET400, the final scores are below the initial scores, indicating that trash levels may be getting worse in this watershed.

Figure 13 shows that the Petaluma River watershed had lower overall scores after the surveys and cleanups than initial scores. While it may be premature to conclude that trash levels are getting worse, it can be reasonably concluded that trash levels in streams are not improving in this watershed.

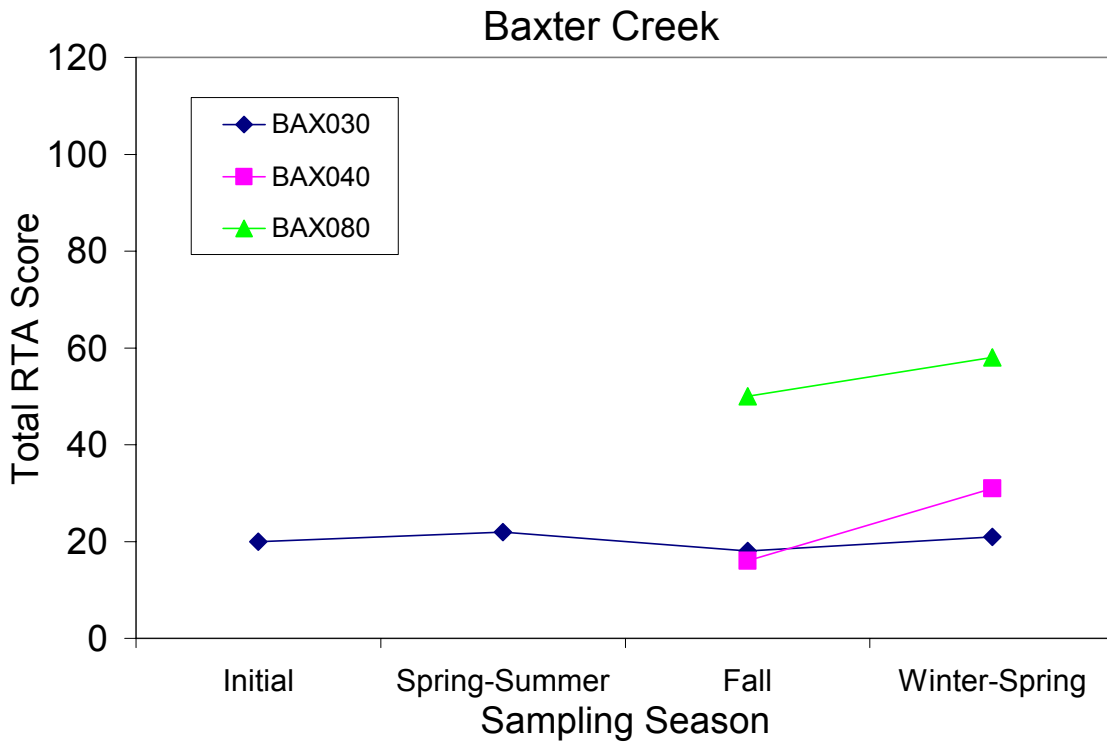
Figure 14: RTA Scores at three sampling sites in the Baxter Creek watershed along a longitudinal gradient. BAX030 is the lowest site, BAX040 is upstream on the main branch at San Pablo Avenue, and BAX080 is at Canyon Trail Park, also on the main branch, in El Cerrito.

The lowest site at Booker T. Anderson Park has been discussed above, and exhibits both dry and wet season inputs of trash. The flatline pattern of scores in Figure 14, at or around the low score of 20, shows a steady level of trash regardless of the trash removal conducted in the surveys, and regardless of season. Similar problems were documented at the next site upstream, but there was less wet season deposition effects than at Booker T. Anderson Park. The site at Canyon Trail Park in the El Cerrito hills had significantly higher RTA scores in dry and wet seasons, demonstrating the longitudinal pattern of trash levels seen region-wide.

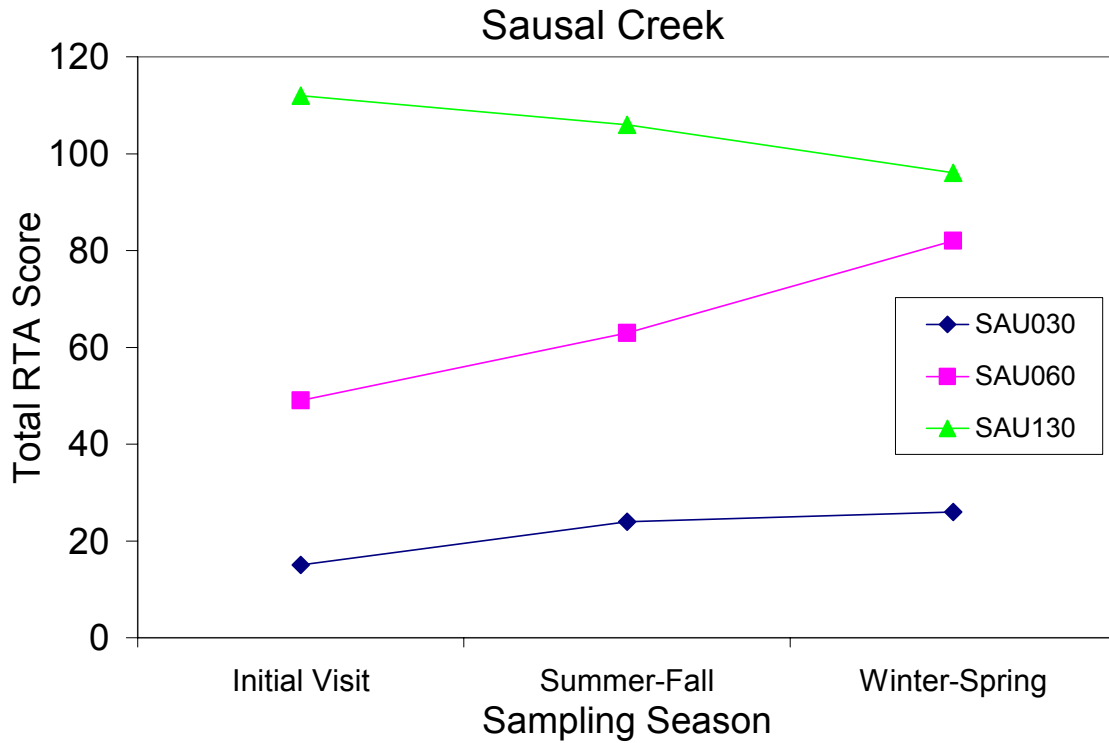
Figure 15: RTA scores at three sampling sites in the Sausal Creek watershed along a longitudinal gradient. SAU030 is the lowest site at E. 22nd Street, SAU060 is at Dimond Park, and SAU130 is on Palo Seco Creek in Joaquin Miller Park, all in Oakland, CA.
